# case study - manhole monitors

## United Utilities

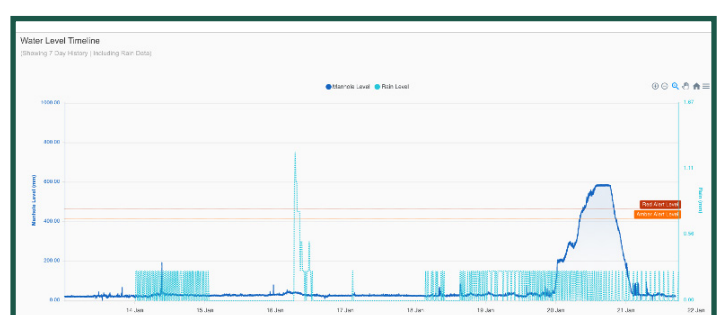
Blockage in sewer shown by peak in graph

After sewer cleanse, shown by drop in graph

Feedback from United Utilities has shown that the implementation of the monitors throughout the network is enabling early blockage detection, significantly improving response times. There have been multiple occasions when the monitors have successfully alerted contractors to a developing blockage, allowing for timely intervention. For instance, in the provided images, a timeline graph clearly highlights a sudden change in water level, which triggered an alert for sewer cleansing. Upon arrival at the site, it was evident that FOG (fats, oils, and grease) was obstructing the sewer flow. This early warning and subsequent action prevented what could have potentially escalated into property flooding, demonstrating the effectiveness of the monitoring system in mitigating risks and maintaining sewer integrity.
